## Technical Tip

# The Use of Steel Wool or a Wire Brush

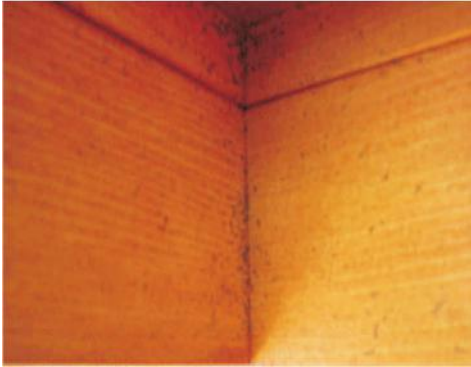
The customer who took this picture thought that the dark spots in the corners were due to mold; however, they appeared within just days after the finish was applied. We were able to obtain a small section of the discolored wood

Most of the Directions for Use for our finishes contain the statement “Do not use *LIFELINE™* on surfaces that have been brushed or rubbed with steel wool or a wire brush. If you do, rust spots may appear under the finish.” Fortunately we rarely see the consequences of applying one of our finishes over a wall that has been rubbed or brushes with steel wool or a wire brush, but occasionally it does happen.

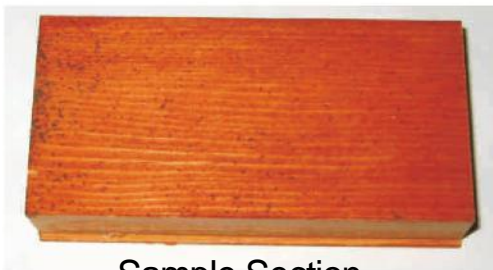
Sample Section

and just looking at it gives the impression that the discolorations could well be mold or some flecks of dirt that may have been present at the time of staining. Even under the microscope at 10X magnification, there's no indication of what caused the black spots.

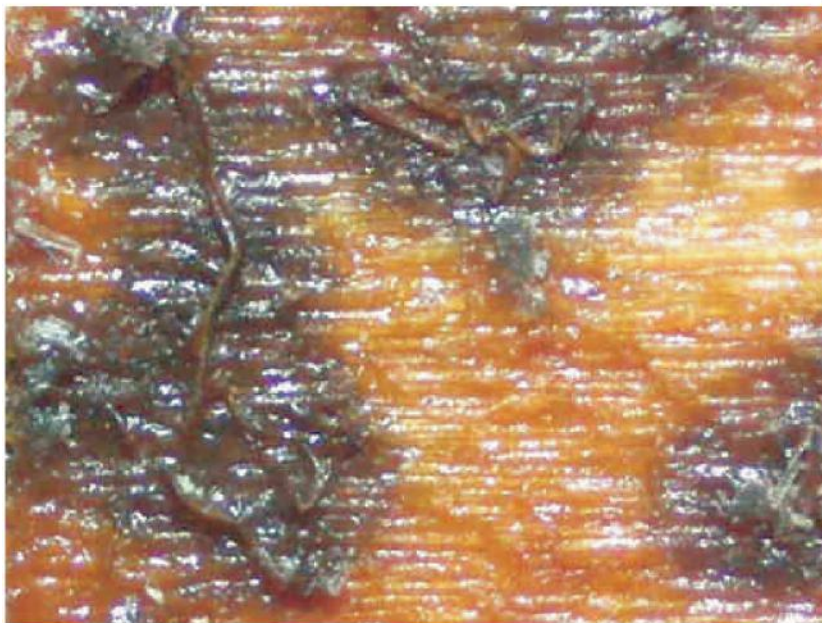
60X Magnification

But at 60X magnification it quickly becomes apparent that every black spot is associated with some type of fiber imbedded in the film. These fibers are bits of steel wool. Since the black spots are concentrated in the corners it's evident that someone had tried to wipe the wall clean but missed the corners entirely.
